DOT/FAA/AR-96/21

Composite Failure Analysis Handbook Update 1

August 1997

Final Report

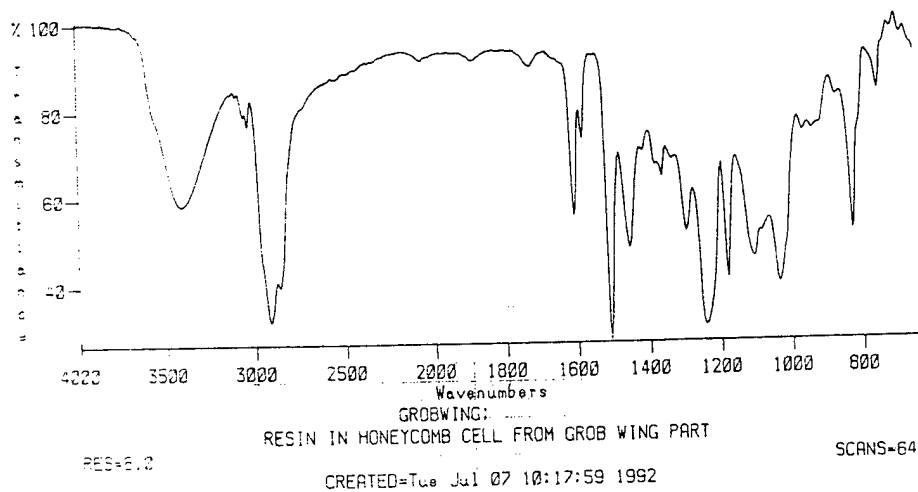
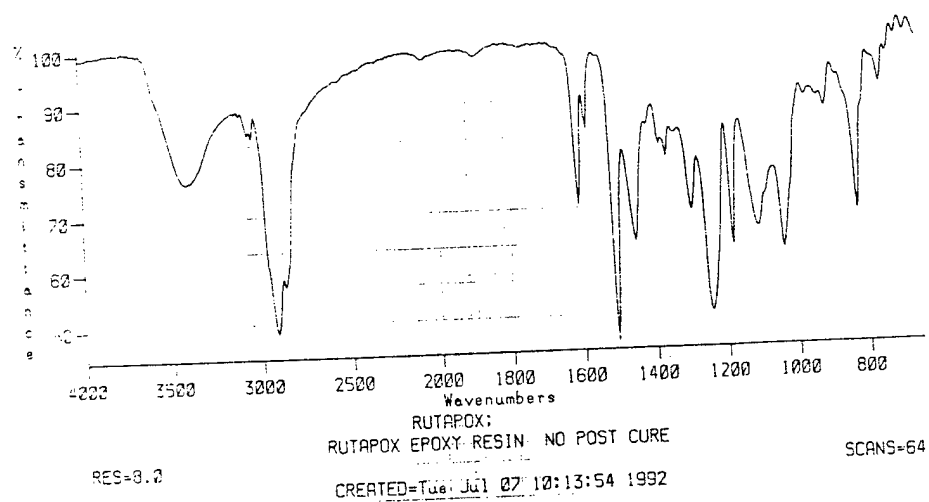
Figure 5. FTIR Plots of the Wing Section Specimen and the Rutapox
a) Wing Section Sample
b) Non-Post-Cured Rutapox Resin Sample

A Fourier Transformation Infrared (FTIR) analysis, used for determining the formulation of polymers, was performed on a sample of the resin used in the skins and compared to a sample of a partially cured Rutapox resin. The analysis indicated that both samples were essentially identical, confirming that wing section was fabricated using the Rutapox resin system (Figure 5).

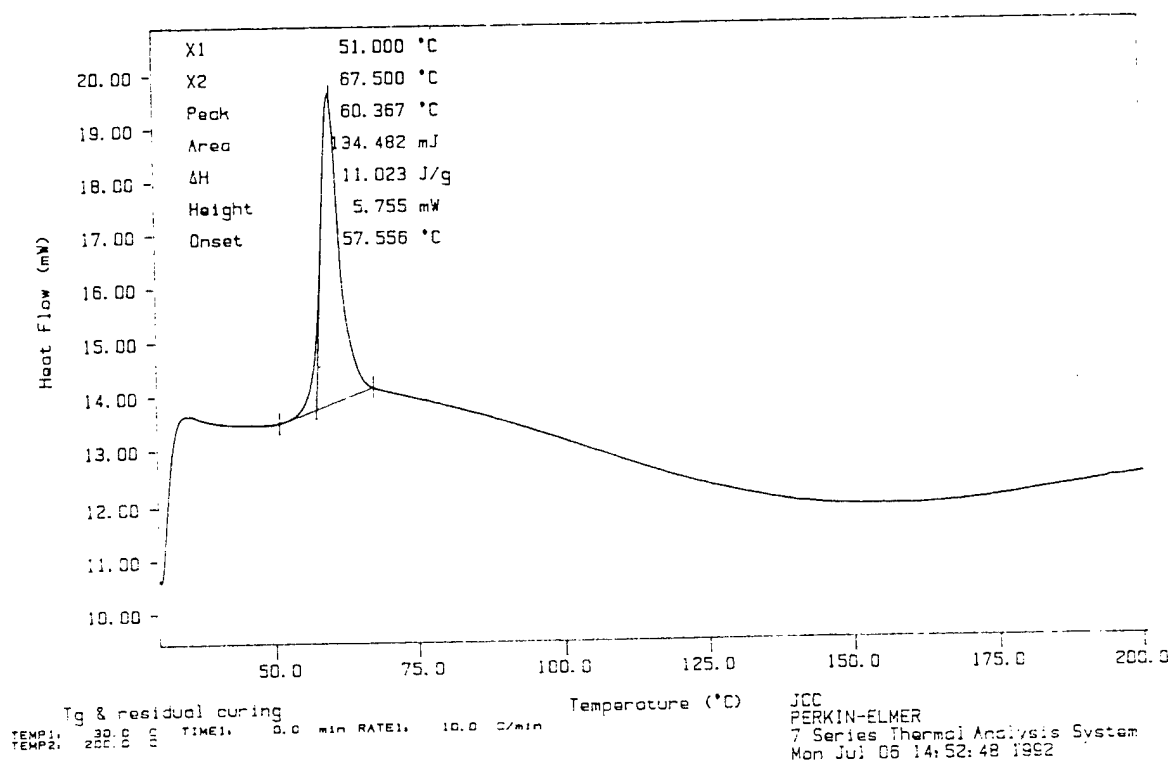
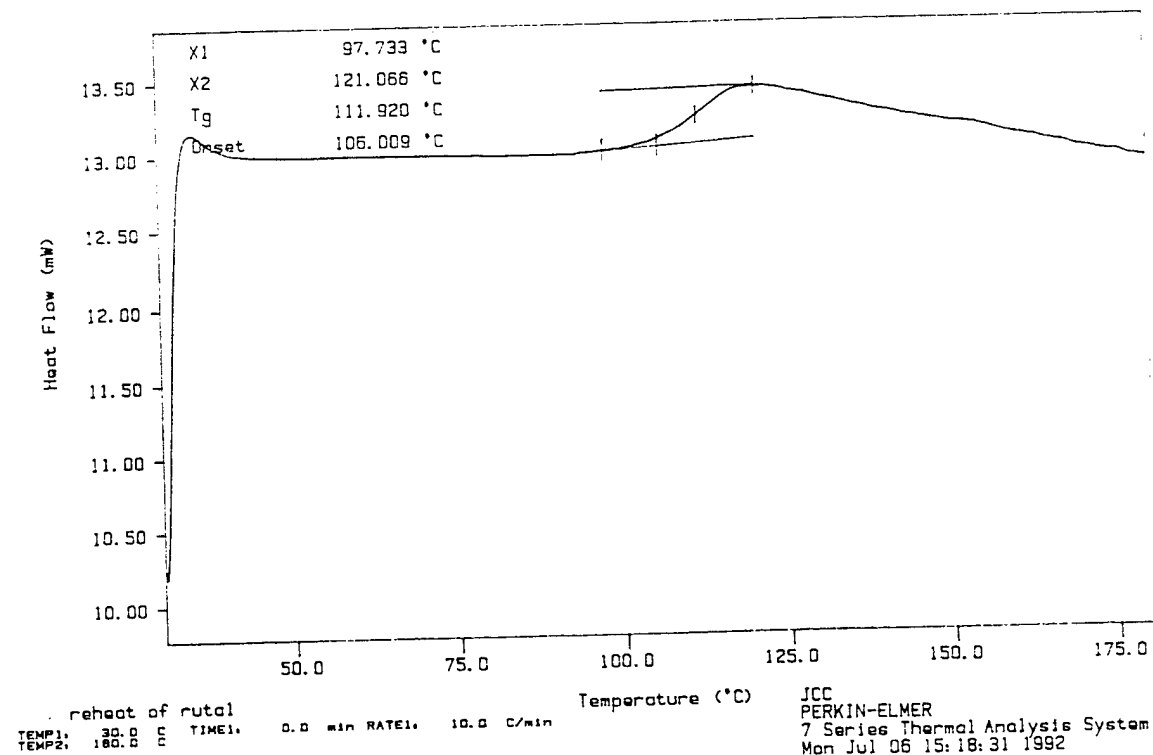
Figure 6. DSC Plots of the Non-Post-Cured Rutapox Sample

Differential Scanning Calorimetry (DSC) analysis was used to determine the extent of curing and the glass transition temperature (T_g). A sample of un-cured epoxy resin was analyzed two times with an exothermic reaction occurring on the first pass. An exothermic reaction did not occur on the second pass but a T_g of 112° C was observed. The next specimen from the wing section was also analyzed twice. No exotherms were

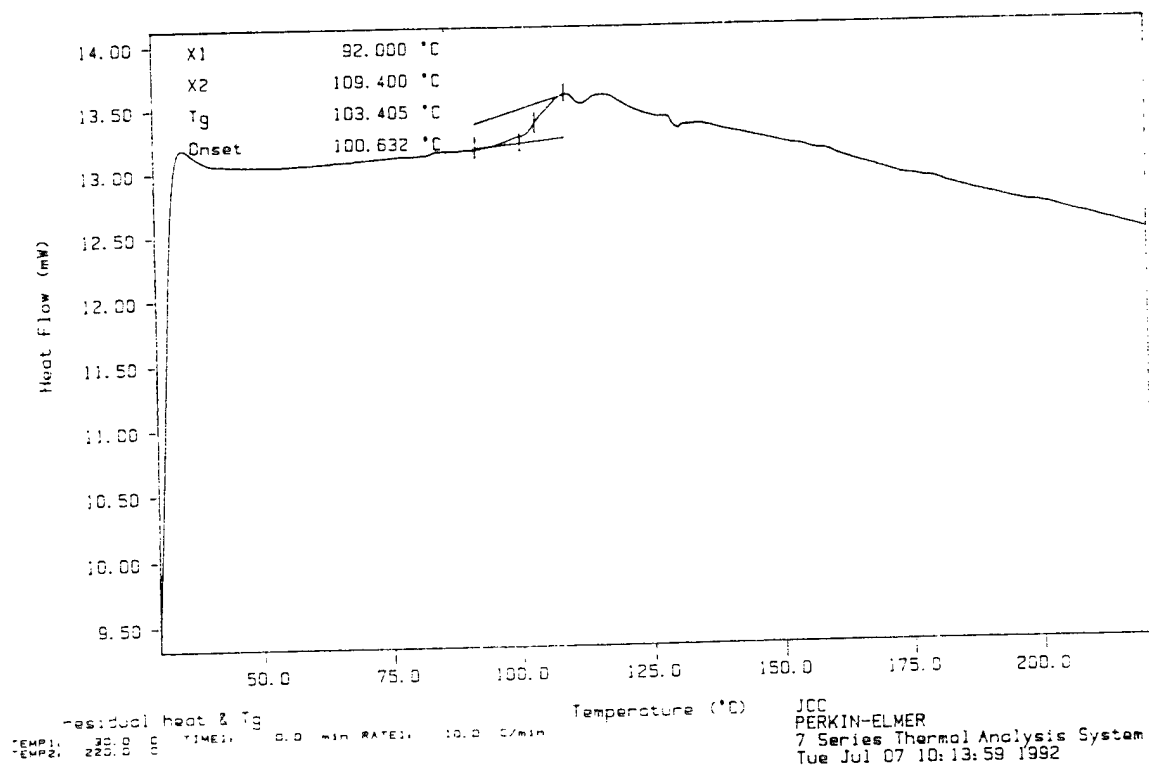
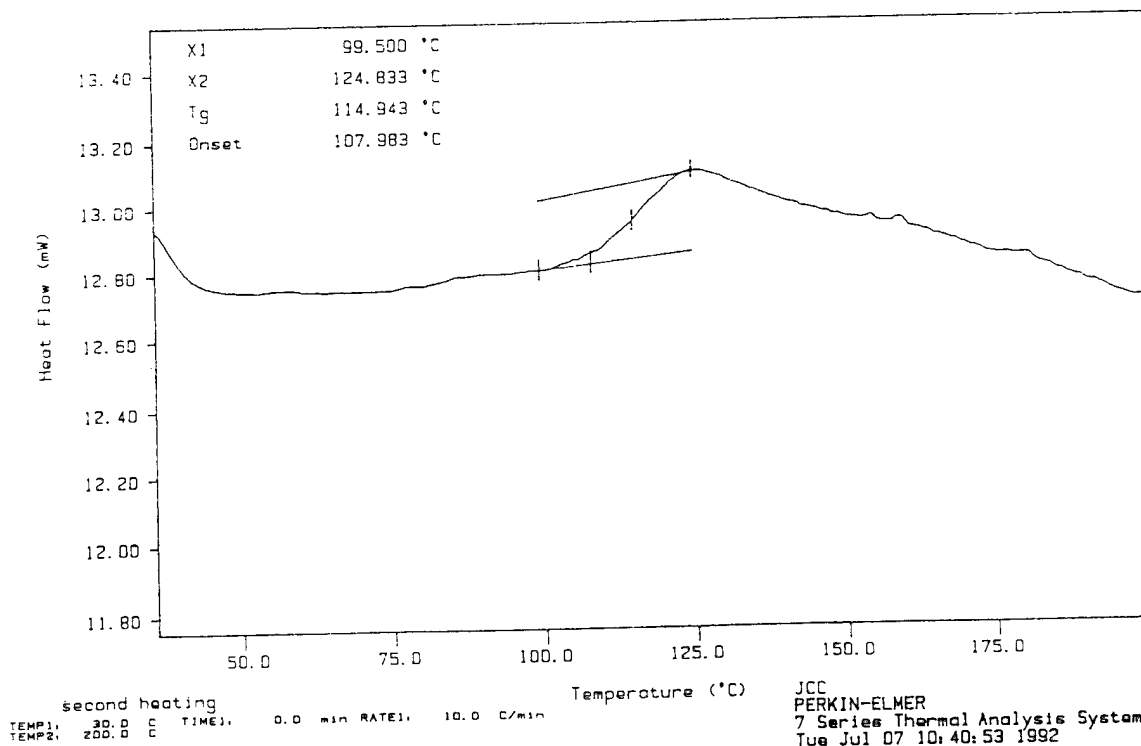
Figure 7. DSC Plots of the Wing Section Specimen

observed on either analyses and the Tg was 103° C and 115° C for the first and second tests respectively. This indicates that the resin in the wing section had been fully cured (Figure 6 & 7).

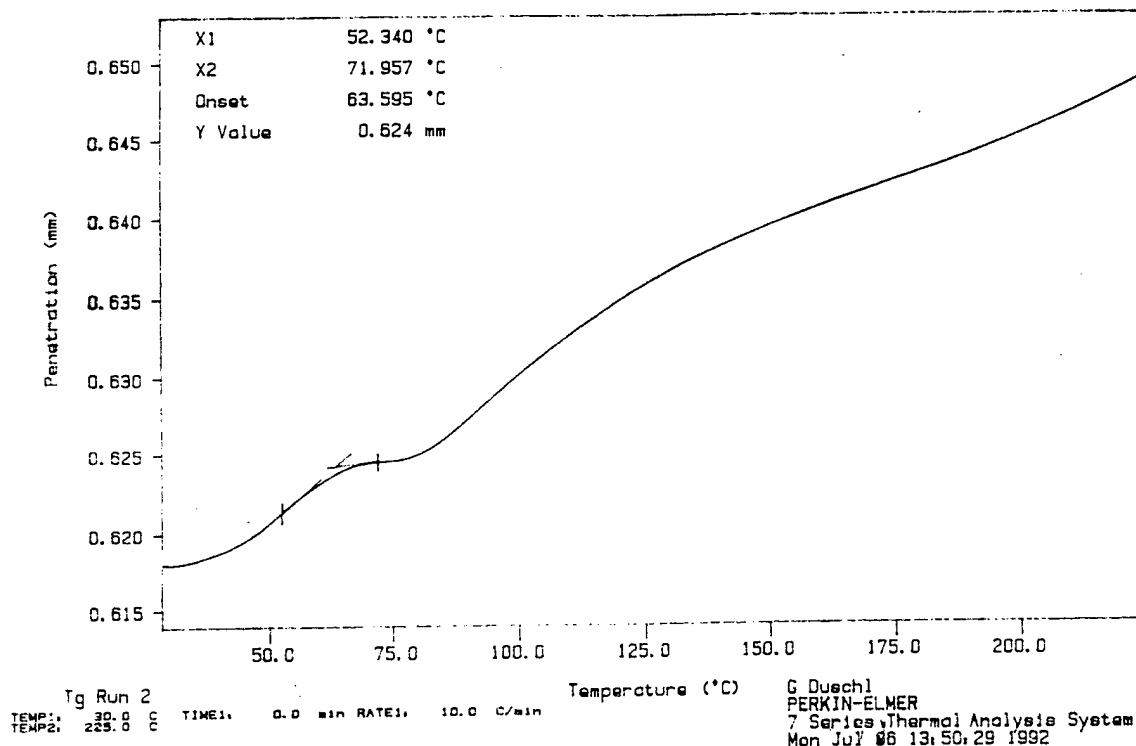
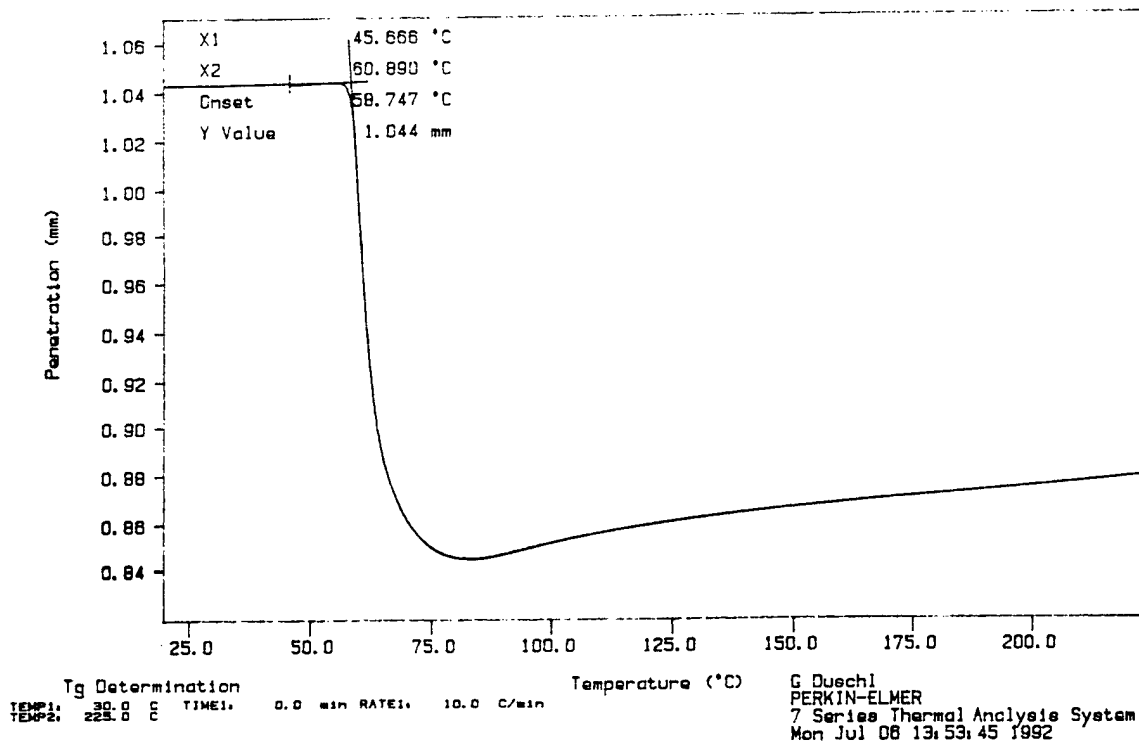
Figure 8. TMA Plots of the Non-Post-Cured Rutapox Sample

Thermo-mechanical Analysis (TMA) is another method to determine the Tg of a polymer. Again two specimens were tested; a non-post cured sample and a sample from the wing section. The first heat cycle of the non post-cured specimen revealed a definite Tg indication at 59°C. Testing of the resin from the wing revealed a Tg of 110°C and 107°C from the first and second runs, respectively. The difference between these two tests confirmed that the wing sample was fully cured because the Tg values were similar to the DSC analysis and that the uncured specimen exhibited a lower Tg and an exotherm. (Figure 8 & 9).
